Seismic Mitigation for Equipment at Army Medical Centers

Methods Illustrated With Examples from Madigan Army Medical Center

by
James Wilcoski

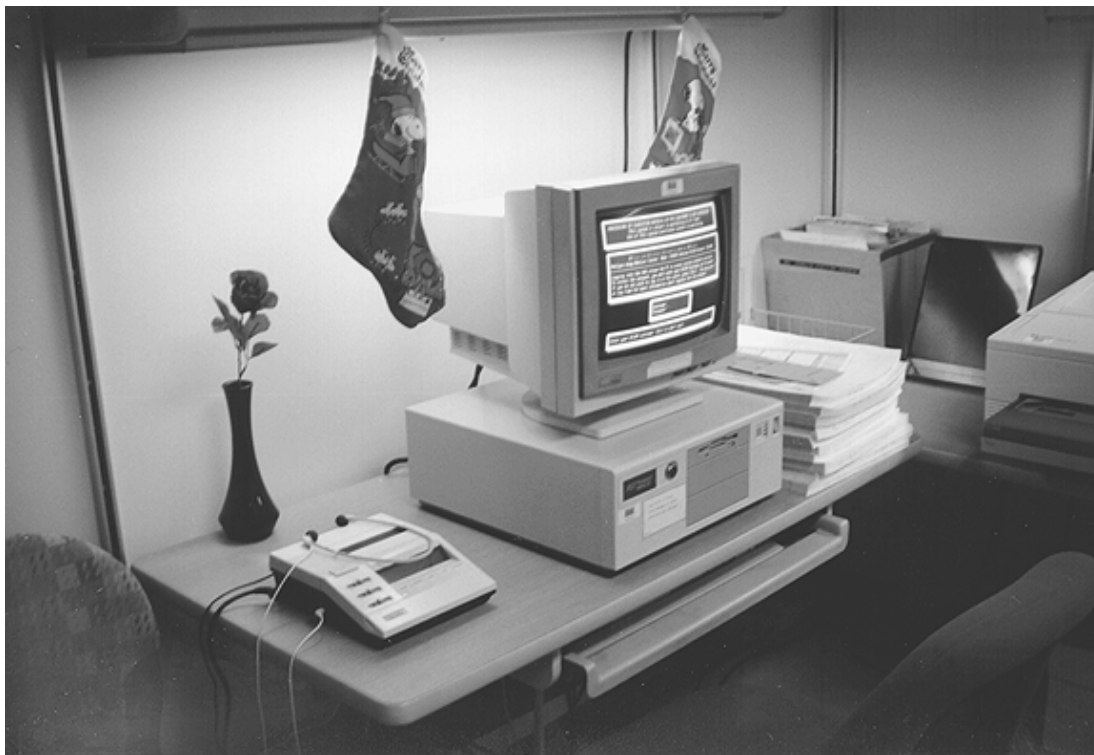
Many offices throughout MAMC have unanchored personal computer CPUs and monitors, as shown in Figure 44. These can easily be anchored to their desks with Velcro strips or double-sided foam tape. The foam material assures that the tape will conform to slight irregularities in the surfaces. Double-coated acrylic foam tape Number 4950, manufactured by the 3M company, has a holding power of about 80 pounds per square inch (0.5 megapascals), so a small patch at each corner would provide an effective restraint. Figure 45 shows typical office file cabinets that are unanchored and may easily topple, blocking escape through the doorway. The drawers on these cabinets have no latches, so several drawers may roll open at the same time, making the cabinets even more susceptible to falling over. Standard file cabinets with latches should be used, and the cabinets should be anchored or braced to the wall or each other as described earlier for shelving units.

Figure 44. Unanchored desktop computer CPU and monitor.

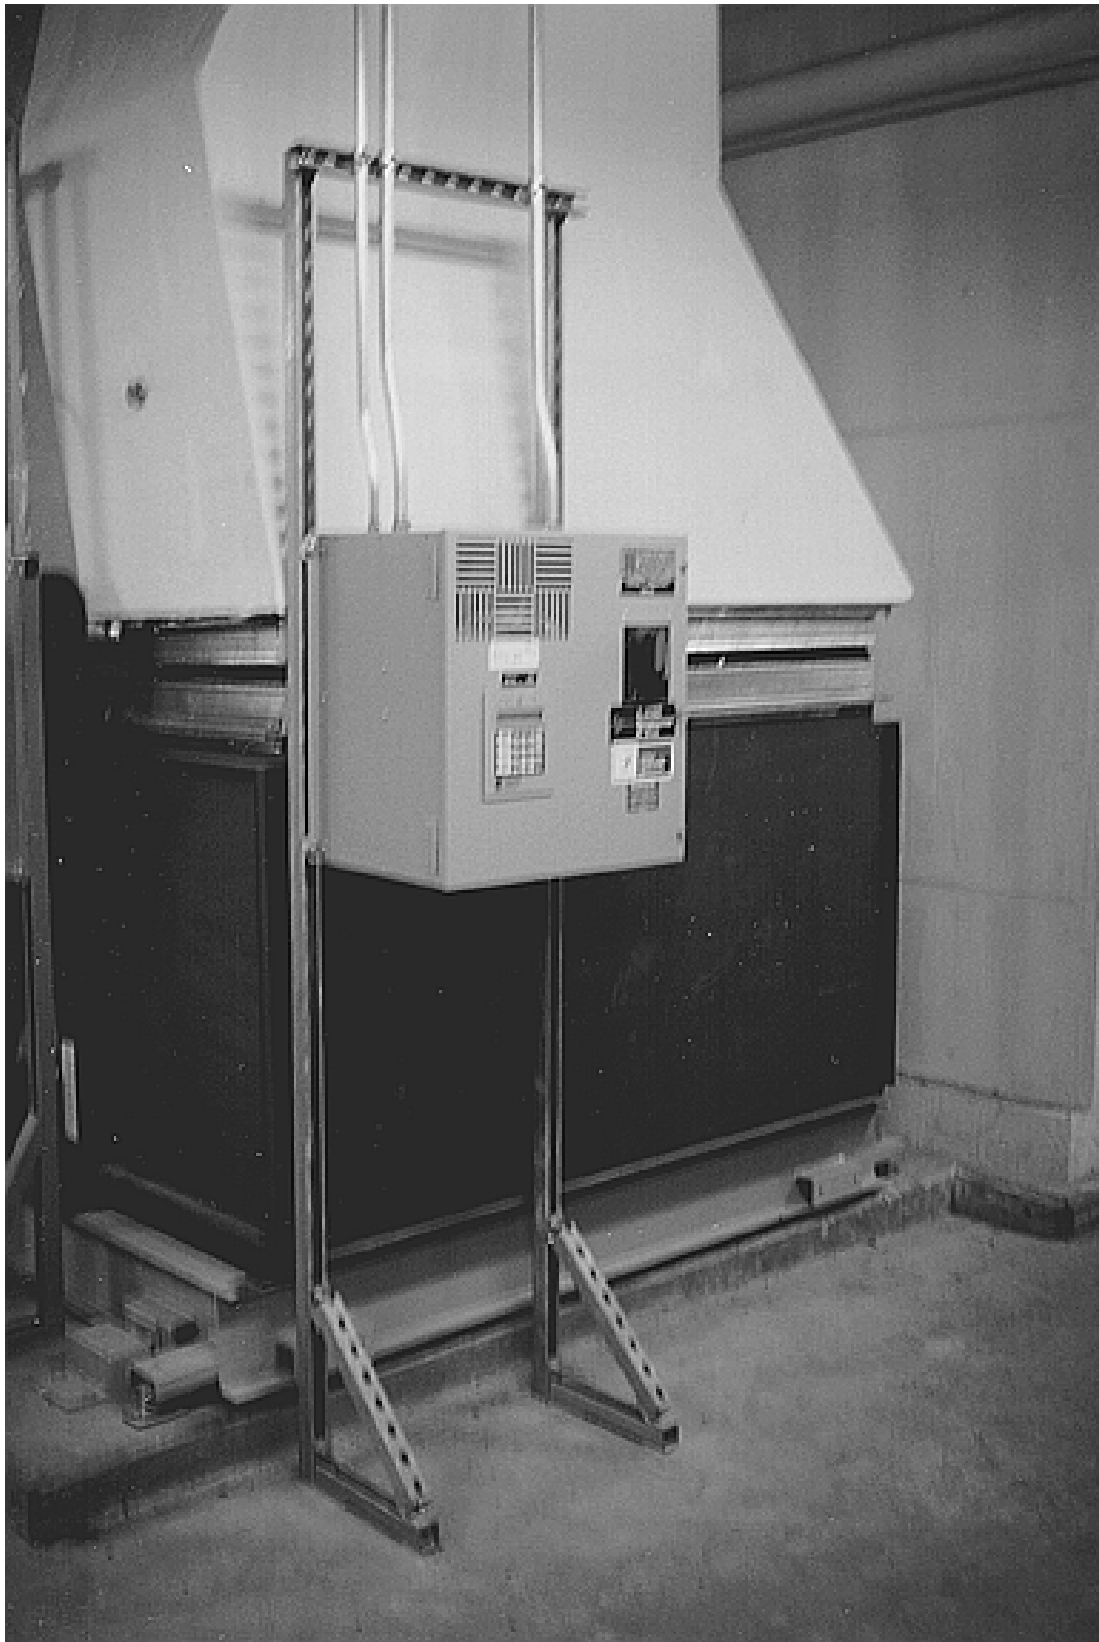
Friction clips, which are often used to support or brace cable trays and various other equipment, should be avoided. Figure 46 shows a Unistrut frame supporting an air-handling unit control panel in a mechanical room. The brace at the bottom of this frame uses friction clips to connect the diagonal members. These clips may work loose after several cycles of seismically induced motions. Such connections should be made with standard fasteners rather than these clips.

Figure 46. Unistrut frame with friction clips supporting air handling unit control panel.

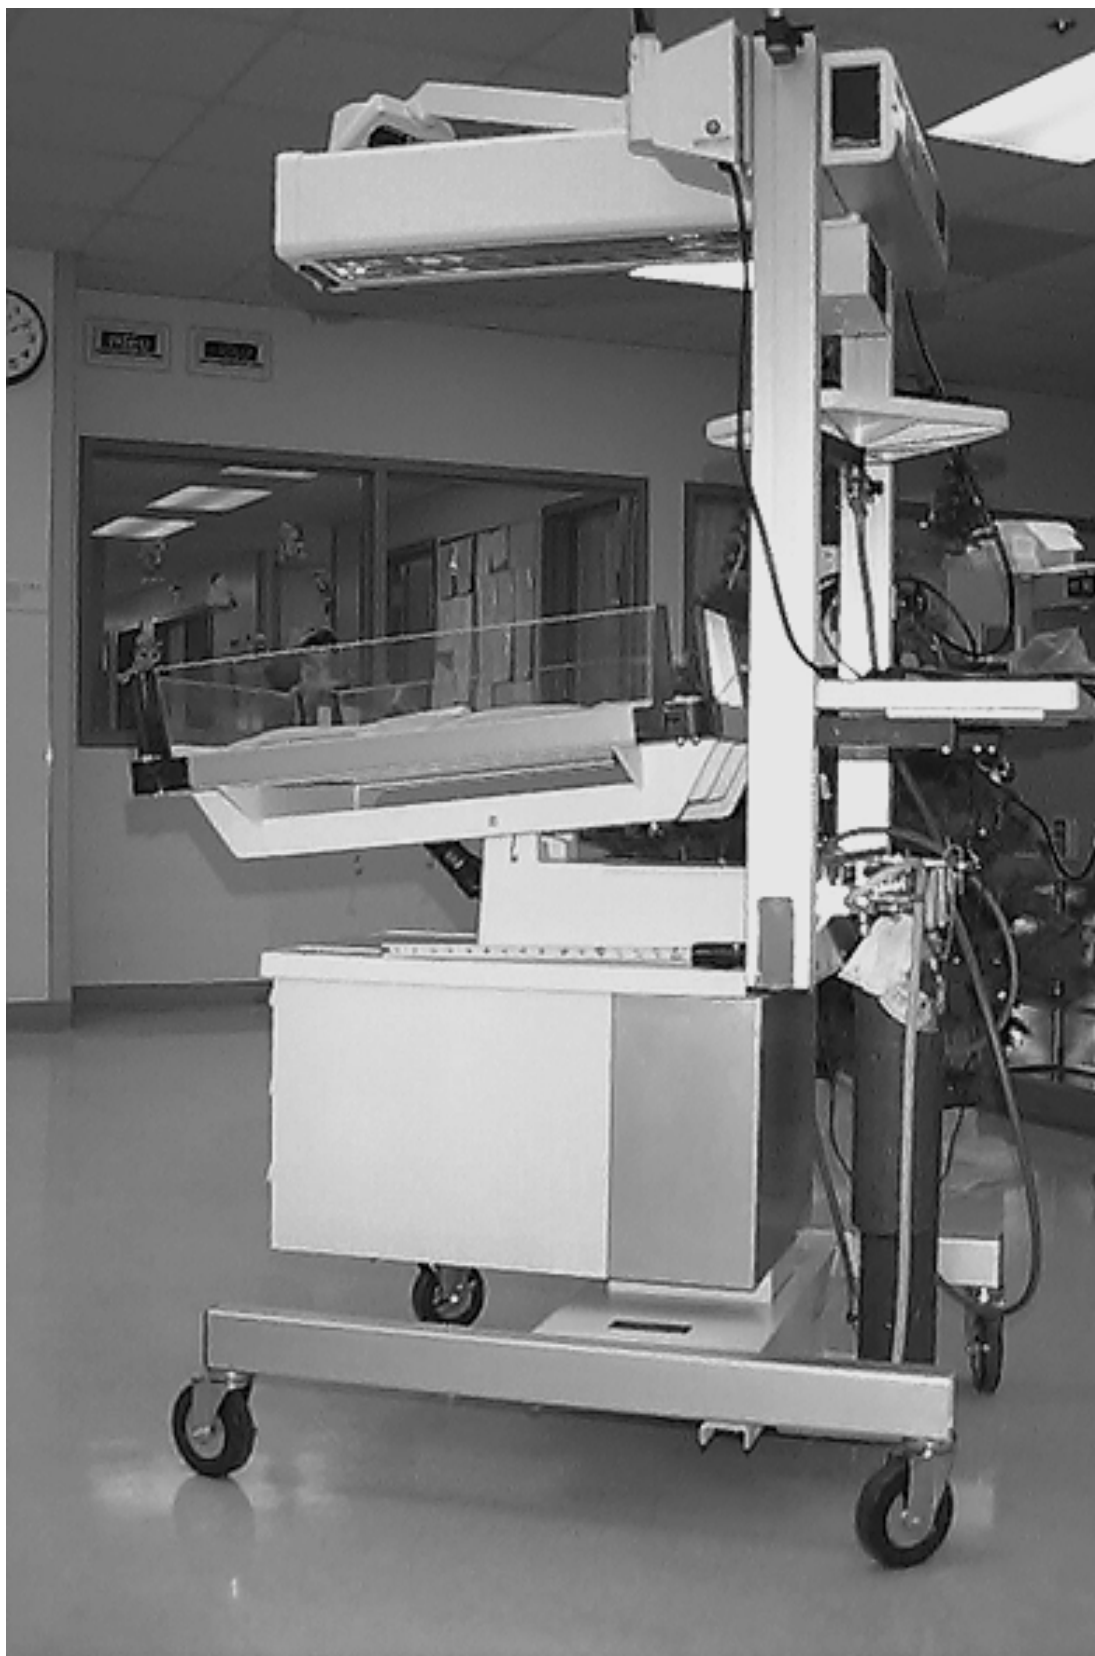
Many examples of equipment on wheels were observed. If the wheels are not locked the equipment will roll around until it strikes other equipment, and may then fall over. If the wheelbase is wide enough the unit may not topple, but the impact may damage either the equipment on wheels or whatever it hits, such as gas lines in intensive care units. It is recommended that the wheels on all such equipment be kept locked. Even with the wheels locked this equipment may fall over if the wheelbase is not wide enough relative to the height of the equipment center of gravity. If such equipment cannot be anchored, it can only be protected by increasing the wheelbase or lowering the center of gravity. Equipment on rollers was seen in the emergency room communications center, intensive care unit (ICU) rooms, ICU nursery, delivery rooms, operating rooms, and in the area near gamma ray cameras. Figure 47 shows a nursery bed on wheels in the ICU nursery. Figure 48 shows a monitor on wheels with a very narrow wheelbase. Figure 49 shows other equipment with a narrow wheelbase near the ICU nursery.

Figure 47. Nursery bed on wheels in the ICU nursery.

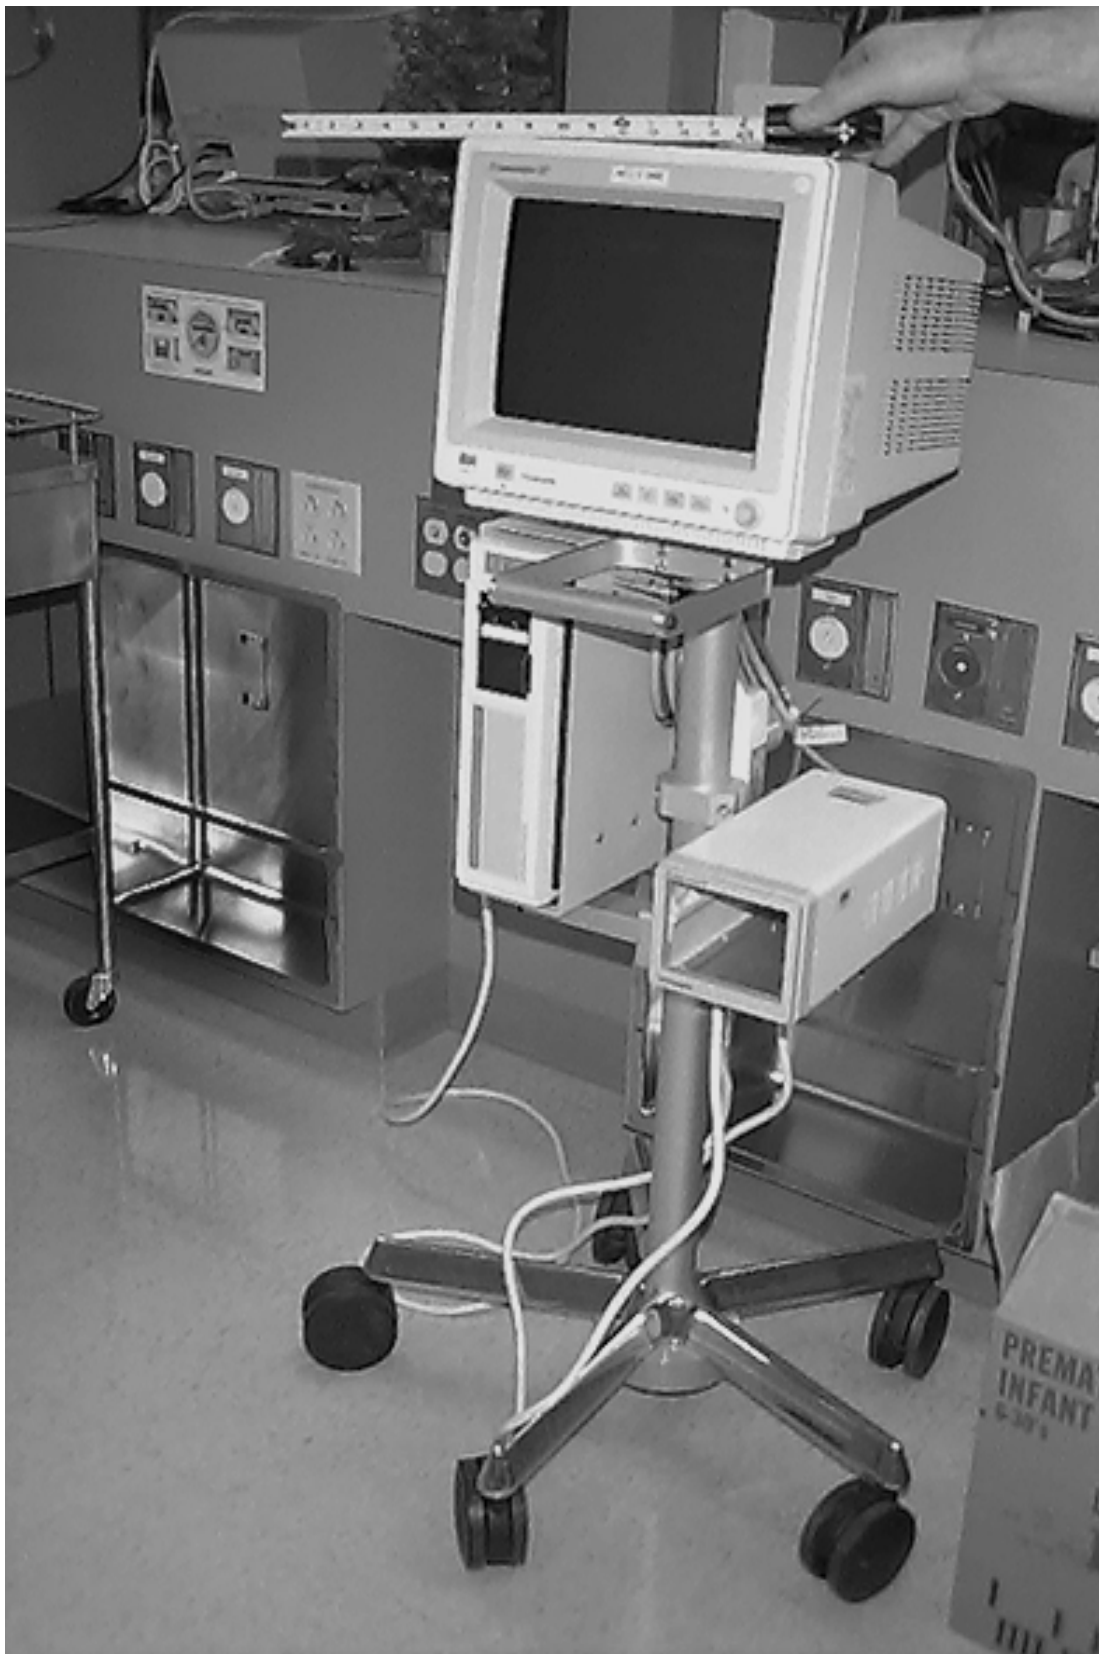
Figure 48. Monitor on wheels with a very narrow wheelbase.

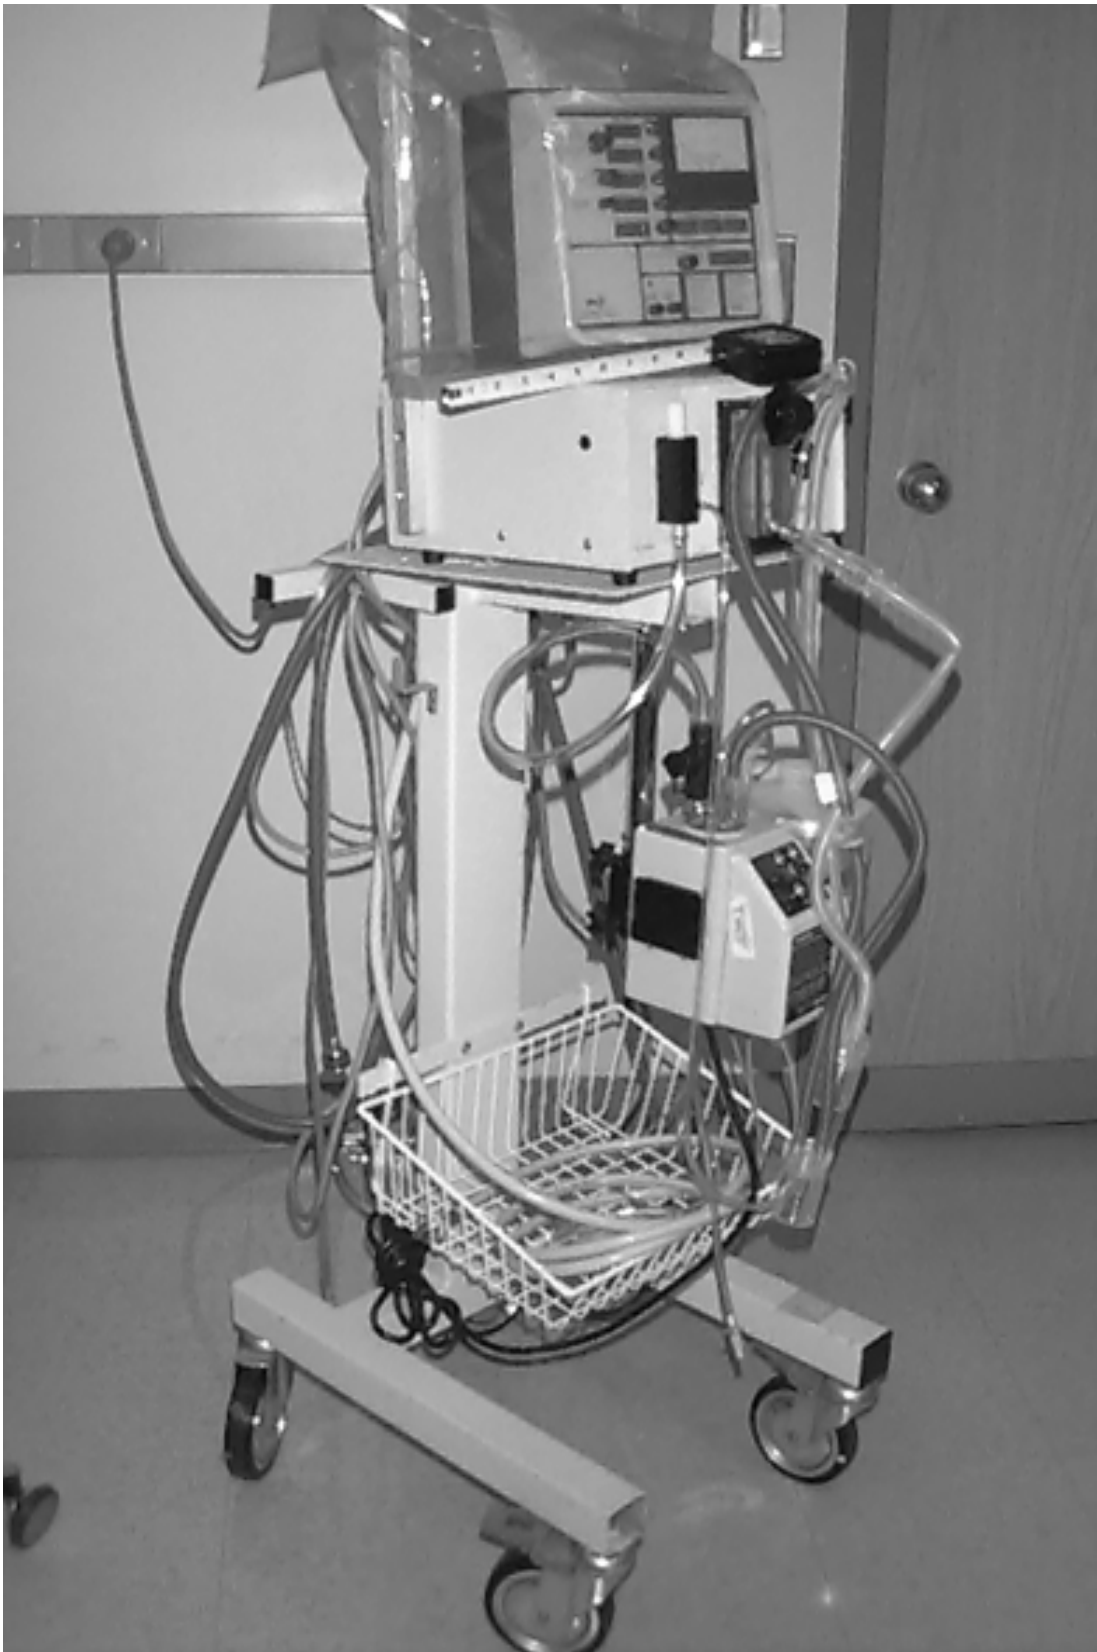
Figure 49. Other equipment on wheels with a narrow wheelbase.

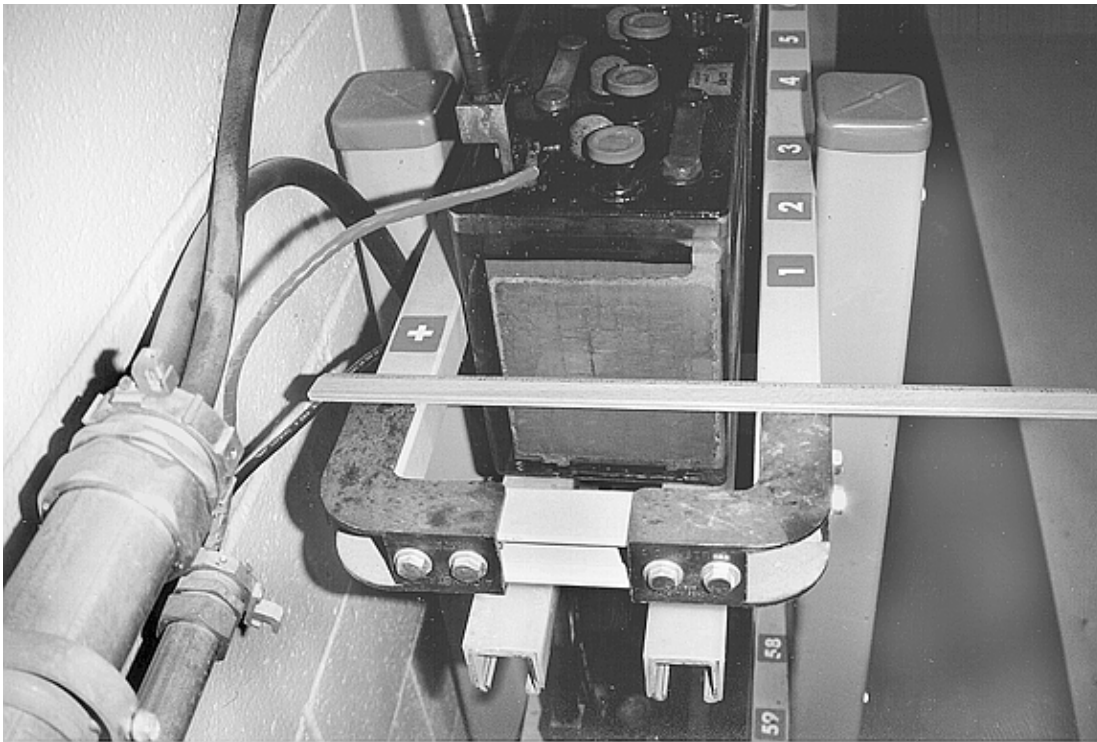
Figure 9 (see Chapter 2) showed the station batteries that comprise the UPS for the switch gear. The frames are well anchored, but Figure 50 shows that the batteries are not snugly supported in the frames. The same foam spacers used between the batteries are needed on the sides of the batteries and at the ends of the racks. The spacers must be sized to provide a snug fit.

Figure 50. Close-up of station batteries showing lack of foam spacers.

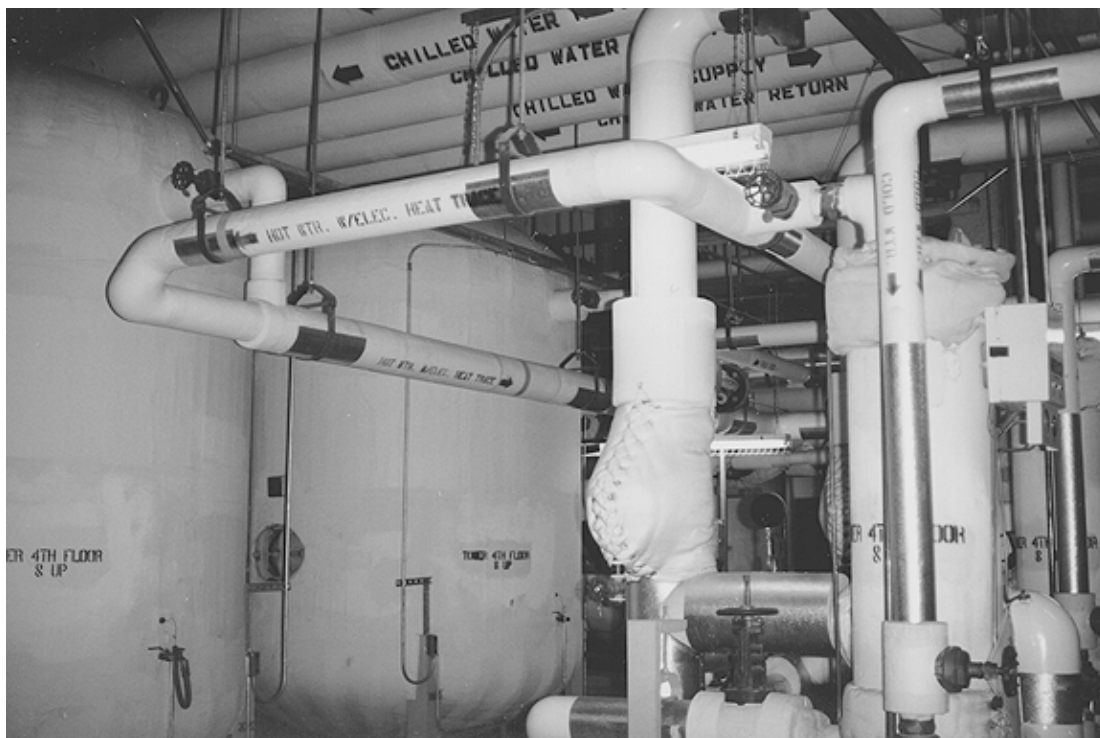
On the left-hand edge of Figure 51 a large hot water tank can be seen. A 4 in. (10 cm) pipe (approximate) connected near the top of this tank couples it to a much smaller tank near the right edge of Figure 51. The pipe is primarily horizontal near the top of photograph in Figure 51. This coupling pipe may cause a problem by not allowing differential movement because it will be very rigid along its axis. In an earthquake the larger tank will oscillate at its own natural frequency, with relatively large displacements near its top. The connecting pipe will then drive the top of the second tank, in the direction of the pipe's axis, with the same motion as the top of the first tank. However, this motion will have a different frequency, phase, and amplitude than the natural motion of the smaller tank. It is important to determine whether the supports for the smaller tank can handle the displacements and forces placed upon them,

Figure 51. Large hot water tank coupled to smaller tank, restraining differential motion.

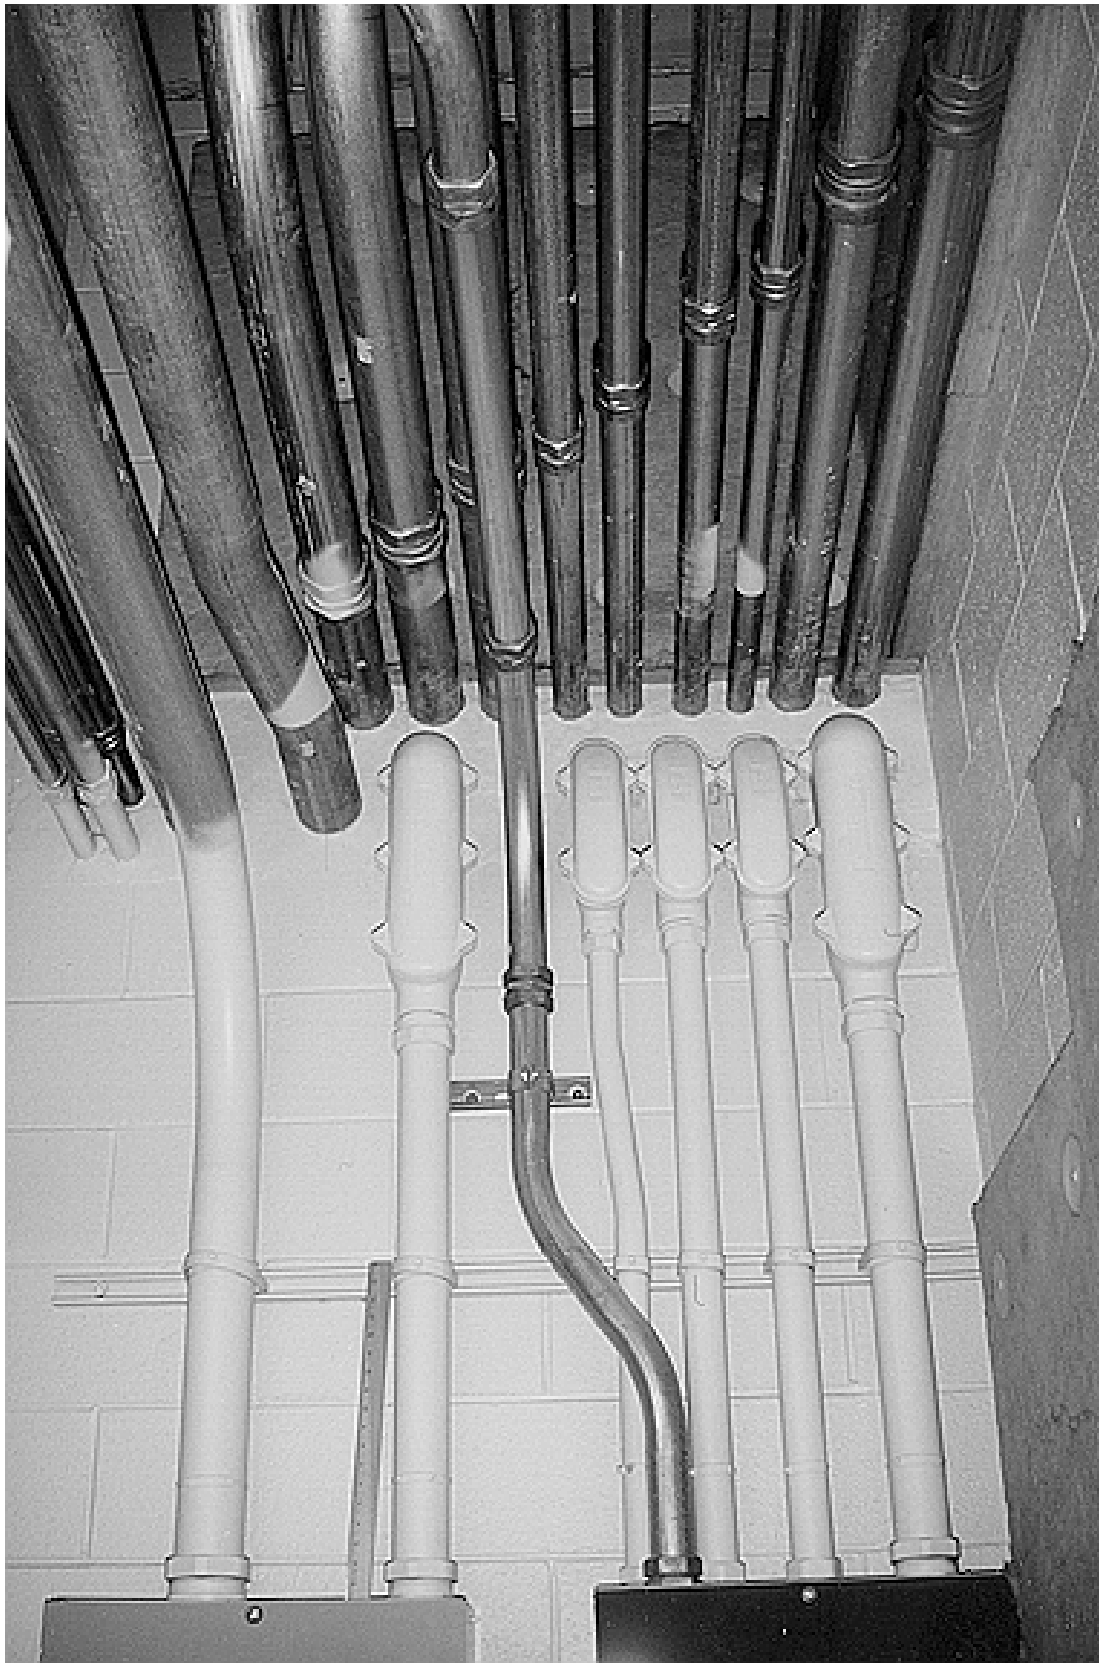
Figure 52. Heavy conduit penetrating CMU wall, loading wall out-of-plane.

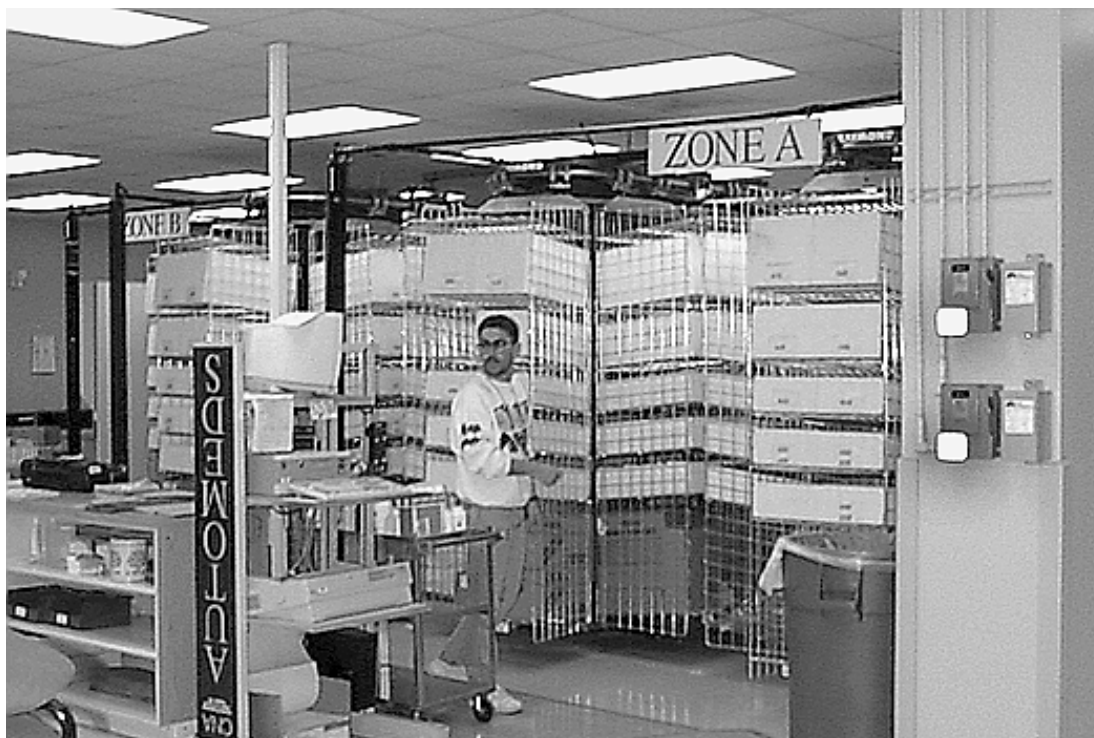
The outpatient pharmacy is supplied by the automated storage racks shown in Figure 53. These movable racks provide 10 days of supply storage. The racks are supported with a structural floor and frame designed to carry 1000 lb (453kg) per 2 x 2 ft (in plan) and 7 ft tall (0.6 x 0.6 x 2.1 m) unit. According to MAMC personnel responsible for this area, the actual weight per unit rarely exceeds 200 lb (90 kg). The logistics area has similar storage racks; their contents appear somewhat heavier, but still well within frame capacity. These frames are approximately 60 ft deep (front to back) and move clockwise along a horizontal track in such a way that racks on the right move toward the front while racks on the left move toward the rear. Therefore, one frame supports about 120 linear feet of 2 x 2 x 7 ft storage units. The pharmacy is equipped with five of these frames. The frames are well anchored to the floor and they appear to be well braced to carry seismically induced lateral loads. The storage units appear to be well supported, with all vertical loads carried along a track at the tops of the frames. The bottoms of these units are restrained by a roller from swinging in against a support bar on the frame, but they are free to swing out — particularly away from the track ends. The racks of one frame are separated from the racks of the parallel frame by only 6 in. Figure 54 shows the bottoms of the racks of two such frames, with the 6 in. separation seen in the

Figure 53. Front view of automated storage racks in the outpatient pharmacy.

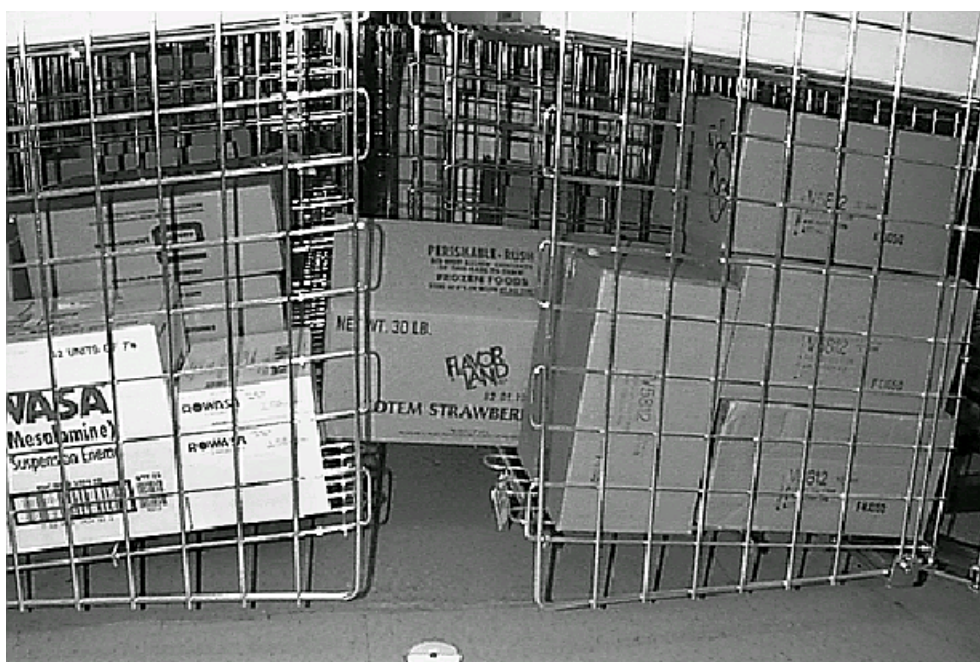
center of the photo. In the center of this photo a box has been laid to span across between the two frames. In an earthquake, these frames will be free to swing out at their bottoms, striking the adjacent racks. Immediately after an earthquake begins the racks should be shut down so this impacting will not bind the racks to each other. However, rack contents such as the box shown in Figure 54 will probably fall out of the racks, or to an adjacent rack, or get wedged between the racks, preventing the operation of the racks temporarily. This debris would need to be cleared away by manually removing rack units, climbing into the racks and removing the obstruction. It may require several hours to clear away the debris but should not cause a long-term problem. If someone attempts to operate the racks before removing this debris, the racks could be forced out of position and bind to each other. If this happened, the rack units or frames could twist, resulting in the need for time-consuming repairs. Therefore, after an earthquake, the racks should be inspected and debris removed to prevent longer-term problems. Figure 54 shows that the base of each rack section slopes in toward the center of the frame, which would help to retain most contents during an earthquake. The actual loss of rack contents should be minimal.

Figure 54. Close-up showing narrow gap between racks at bottom of automated storage racks.

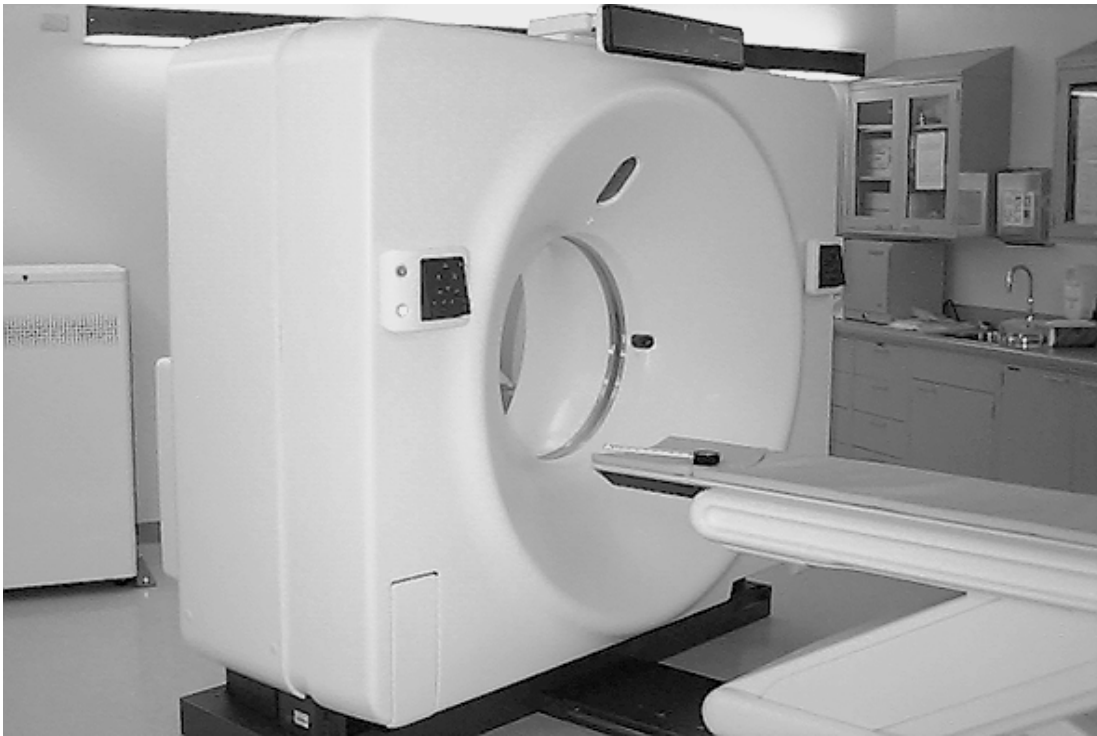
Figure 55 shows a General Electric (GE) computed tomography (CT) scanner. According to medical staff at MAMC, the x-ray tube and detector array rotate in the circular ring shown in Figure 55. These can easily move out of alignment during a seismic event — particularly while spinning. The CT scanner may be the most vulnerable medical equipment at MAMC and, as noted previously, is of particular concern to medical staff.

Figure 55. General Electric CT Scanner, potentially the most vulnerable equipment at MAMC.

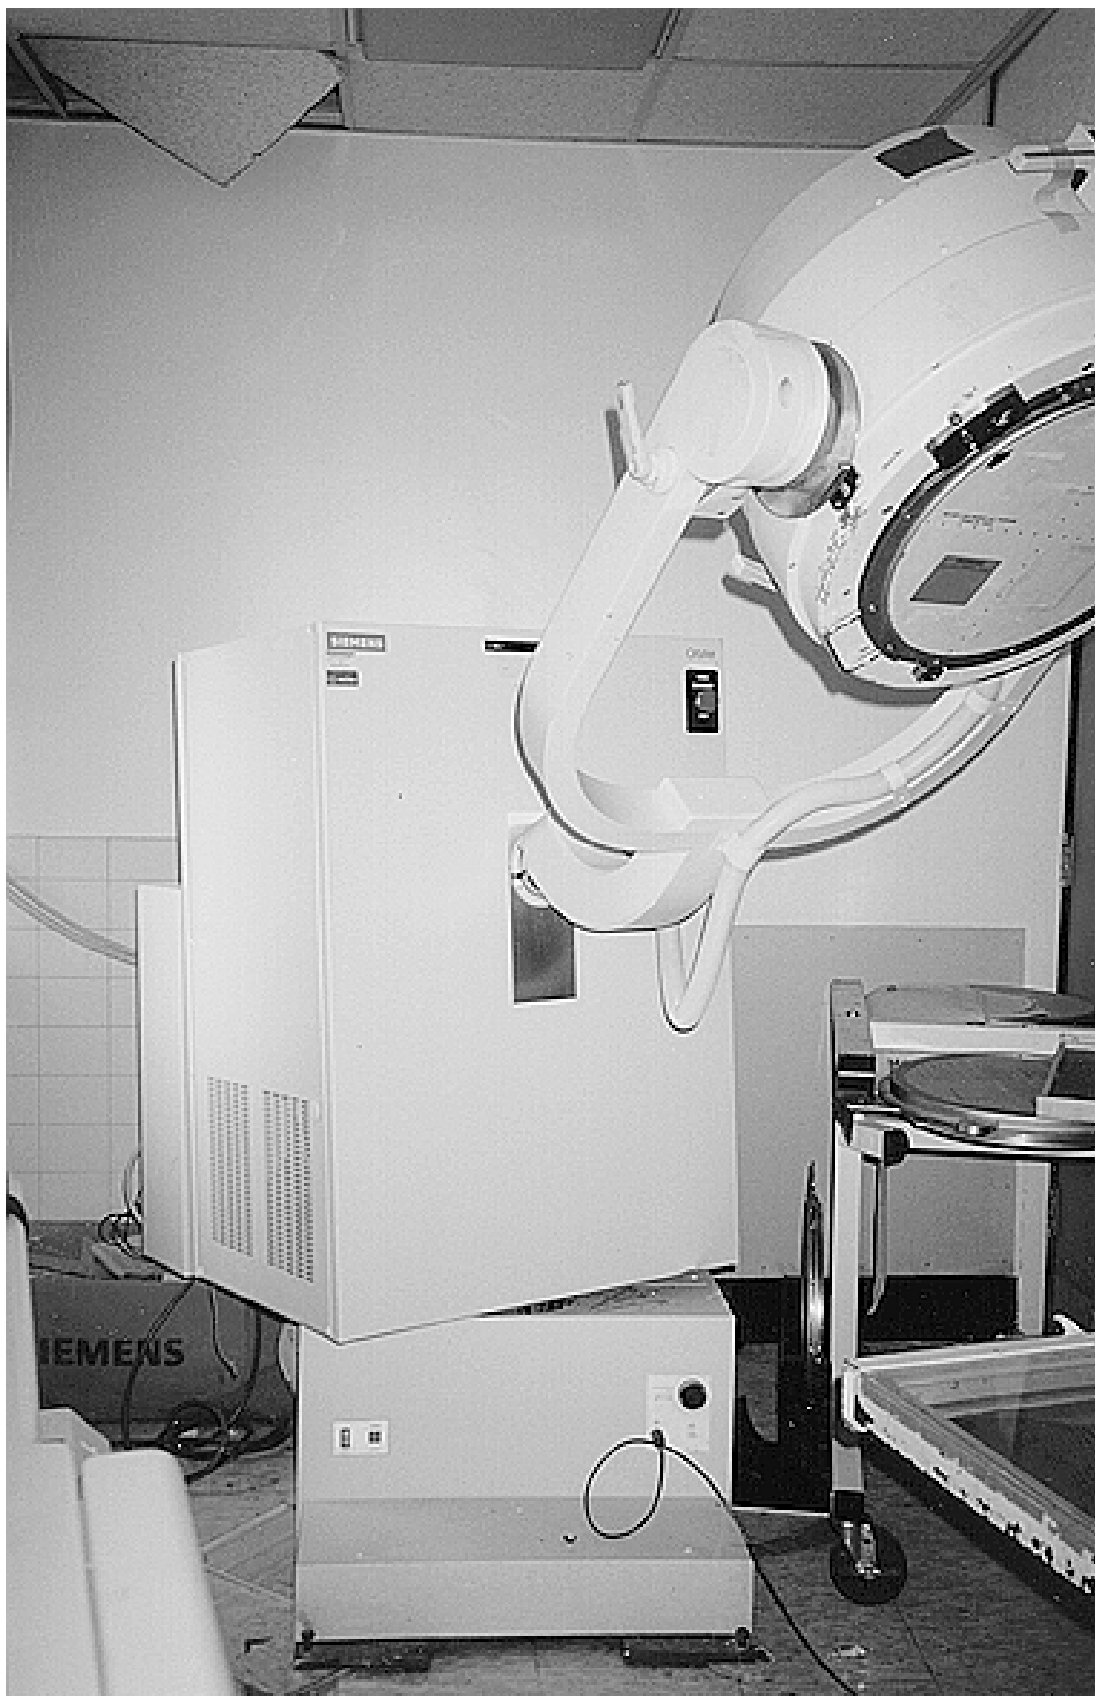
Figure 57. Single-head gamma camera damaged in the 1994 Northridge earthquake.

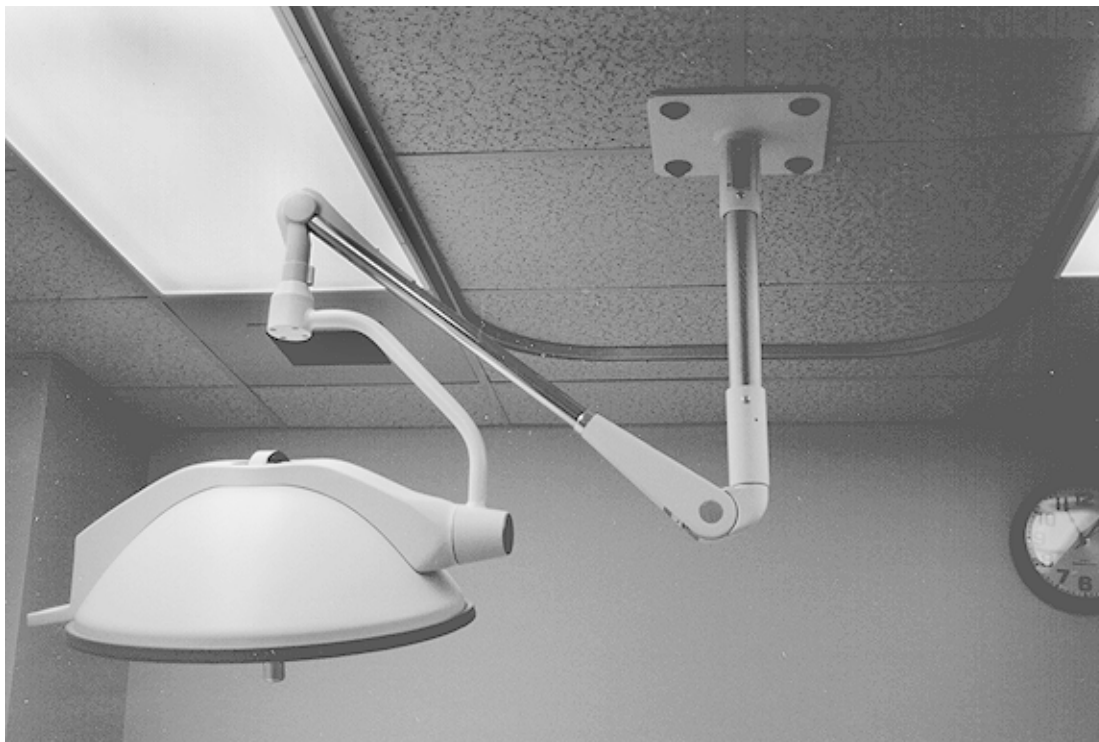
Overhead examination lights such as the one seen in Figure 59 are located throughout MAMC. These are well anchored to the roof above, but the supporting arm appears questionable, especially when fully extended. These may have been seismically qualified, but further investigation is needed to verify that.

Figure 59. Overhead examination light, typical of those located throughout MAMC.
